8x931AA, 8x931HA USB Peripheral Controller

Specification Update

August 1998

Order Number: 273140-006

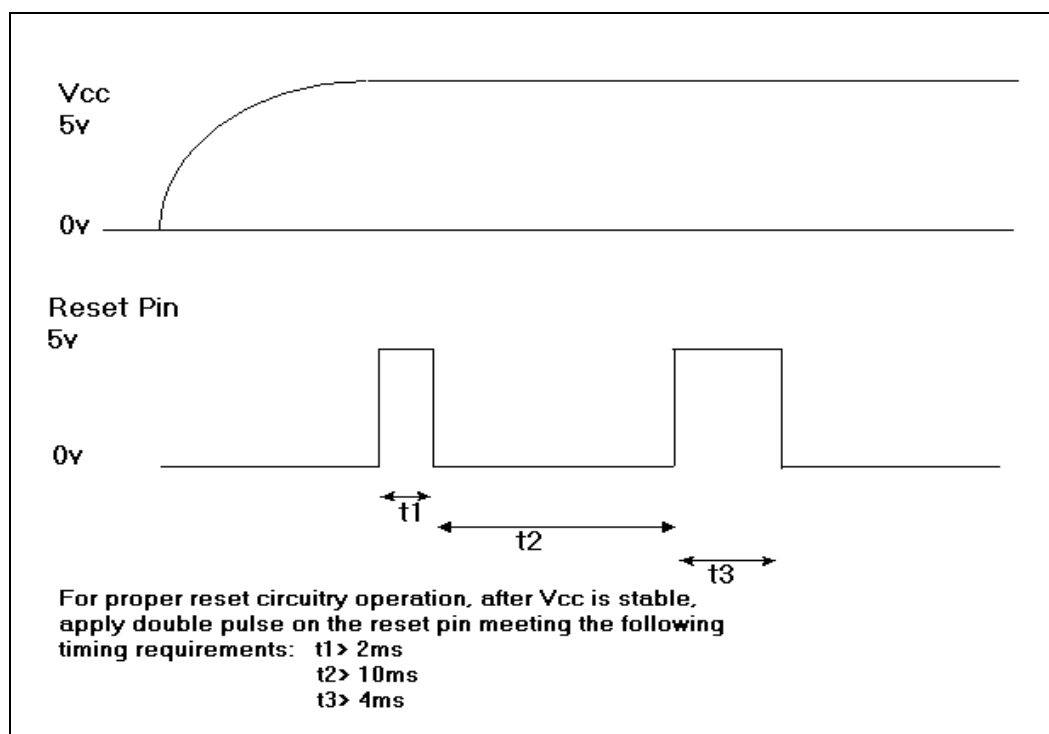
Figure 2. Circuitry for Cold-Boot Errata

- Problem:** It has been discovered that members of the 8x931 USB Peripheral Controller family may not function after a cold-boot on certain PC systems. Intel has discovered on some PCs, that a small voltage (80mV – 1.0V) is present on the USB +5v connector pin when the system is powered off. This voltage coupled with 8x931 reset sensitivity can cause the 8x931 to fail to enumerate properly after a cold-boot power-on. This issue occurs when the "PC-off" USB supply voltage at the pin is between the range of 80mV – 200mV.

- Implication:** 8x931-based USB peripherals, when attached to a PC that has been cold-booted, may not enumerate after power-on if the PC provides partial power to the USB bus when powered off.

- Workaround 2:** The second method entails the addition of reset circuitry which provides a double reset pulse instead of a single reset pulse at power-on. The reset signal shown in Figure 2 below has been characterized as a possible workaround for the cold-boot errata. Note that this reset pulse can be implemented in various manners. Intel is currently testing several of these methods and will publish them as part of this specification update when testing is completed. Note that use of this or any workaround should be validated by the implementer for given applications.
